Whitetopping Performance in Illinois

FINAL REPORT
PHYSICAL RESEARCH REPORT NO. 148
JANUARY 2005

Illinois Department of Transportation

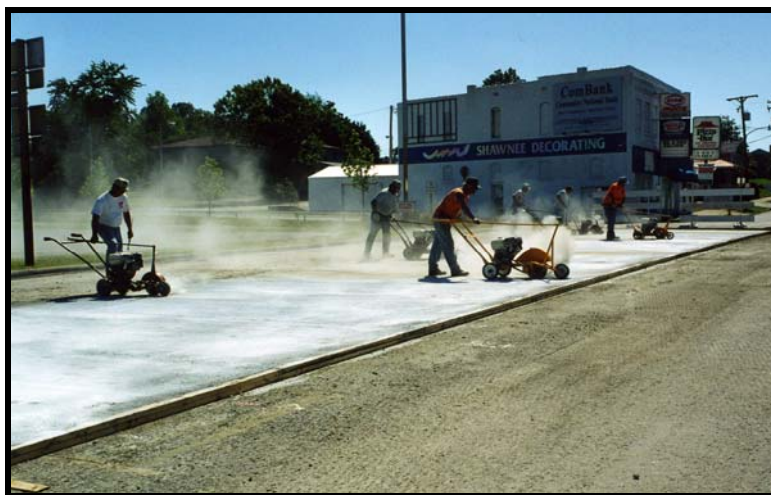
Figure 12
Partial-Depth Relief Joint Saw Cutting

Relief joints were laid out on a regular pattern of 3.0 feet by 3.0 feet throughout the intersection; however, some joints were shifted slightly in order to place them directly over an underlying transverse crack in the original pavement. Early entry saws were used to cut the partial depth relief joints as shown in Figure 12 below. Full-depth relief joints were placed over most transverse cracks and all construction joints in the underlying pavement. Full-depth relief joints were filled with a hot-poured joint sealant.

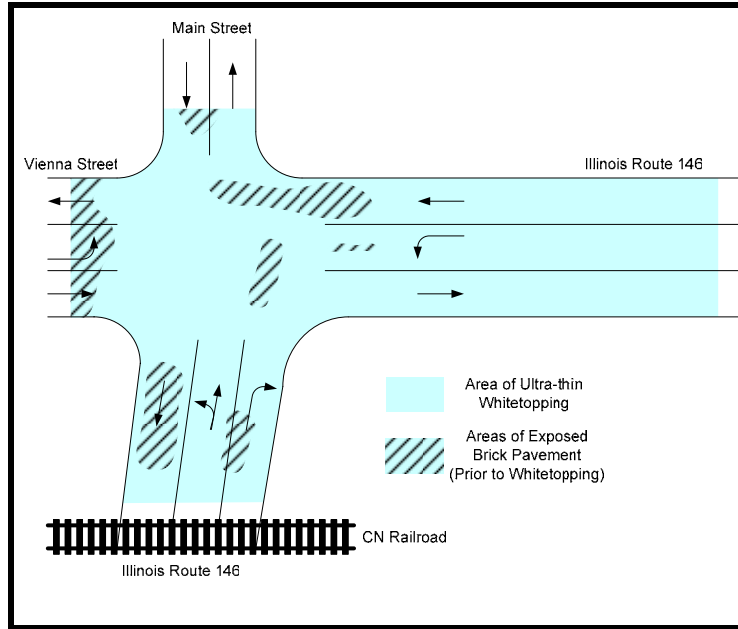
Figure 15
Anna Project Layout

The second additional research project was constructed in June of 2001 at the intersection of Vienna and Main Streets along Illinois Route 146 in Anna. This rehabilitation included all of the trafficked lanes within the intersection. This project is unique, in that it is a combination of ultrathin whitetopping and a bonded concrete to brick inlay. The areas of exposed brick were not very well defined; however, their approximate locations may be seen in Figure 15 along with the project layout.
